NUMERICAL STUDY OF THE STABILITY OF RESTORING DAMAGED SCULPTURE

Laura Michel^{1,2}, Duc Phi Do¹, Dashnor Hoxha¹, Benoit Coignard³, Xavier Brunetaud²,
Muzahim Al Mukhtar²

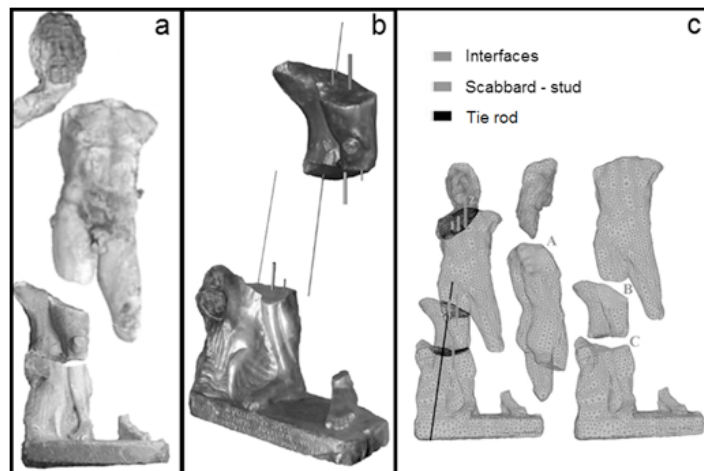
Figure : Blocks of the broken sculpture (a) and numerical model of the reinforced statue (b, c),

For the Neptune statue reinforcement elements contains five pile elements (modeling studs) and a cable element of Flac3D (modeling the pull cable in the statue). Also, in Flac3D, the 1D cable structural element is associated with the 3D structure through a set of nodes which are modeled as a spring - slide system characterizing the shear resistance of the grout between the cable and rock mass. Their properties describe the grout stiffness, the grout cohesive strength, the friction angle and the exposed perimeter of grout. The interface between tie rod anchoring and stone is represented by the shear behavior of the grout annulus which is frictional and cohesive in nature. Thus the cable element can sustain the tension and compression forces. In addition, the pre-tension force can also be taken into account in the cable element which is maintained by the anchorage length located in the torso block and maintained under the lower block.

Finally to model the contact between the fragmented pieces, interface elements are defined on meshed surfaces. In Flac3D the contact takes place between the interface nodes and a surface zone known as the target face. These contacts are hence detected only at interface nodes. Moreover, the associated model is defined by a linear Coulomb shear-strength criterion. Consequently, the interface elements are characterized by their properties which consist in friction angle, cohesion, dilation angle and normal and shear stiffness. In Figure c three interfaces between four fragments of statue were well illustrated.

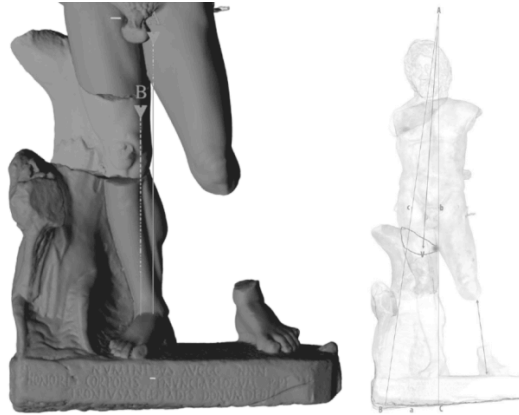
Figure : Restorer calculation as rigid solids, gravity vectors of blocks and those of their stacks

The second stage of this methodology (Figure 3) is the determination of the weight and the centers of gravity of each block and the assembly of these blocks. So, the preliminary virtual reassembly defined the vectors of gravity of the whole of successive blocks to measure their incidence on the lower blocks (the vector of the block of the head, then the association head / trunk, and finally of the association head / trunk / knee) to carry out a graphic analysis of static stability of the statue. An overhang was observed

showing that the vertical axis of the vector of gravity of the higher blocks in supports on the knee passes tangentially outside the leg. The application of this methodology leads to some alternative solutions such as:

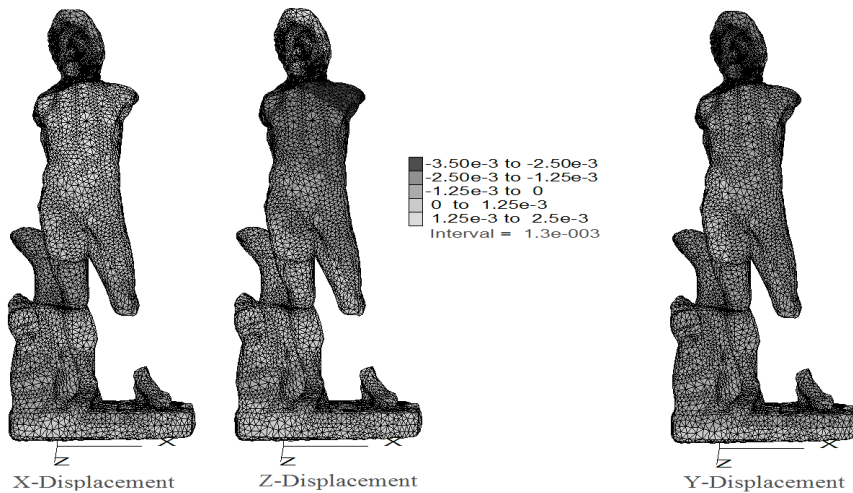
Figure . Vertical and horizontal displacements

In Figure , vertical displacements of blocks in Y direction are represented on the right (Y axis follows the feet-head direction of the statue) while horizontal displacements of blocks are on the left. Under the influence of its own weight the torso switches to the left and back and also pivots around the vertical axis of the statue, taking with him the head and the knee. While, the head moves along the inclination of the upper interface. Figure shows that the maximum displacements are on the block head with values of 2.3 mm for the vertical displacement and 1.8 mm for lateral movement. Moreover, the stress on inserts is small and represents about 20% of the metallic yield strength.
